This Service Information bulletin supersedes S.I. B11 07 03 **dated February 2004.**

Engine Low Oil Level Warning With Ignition Off

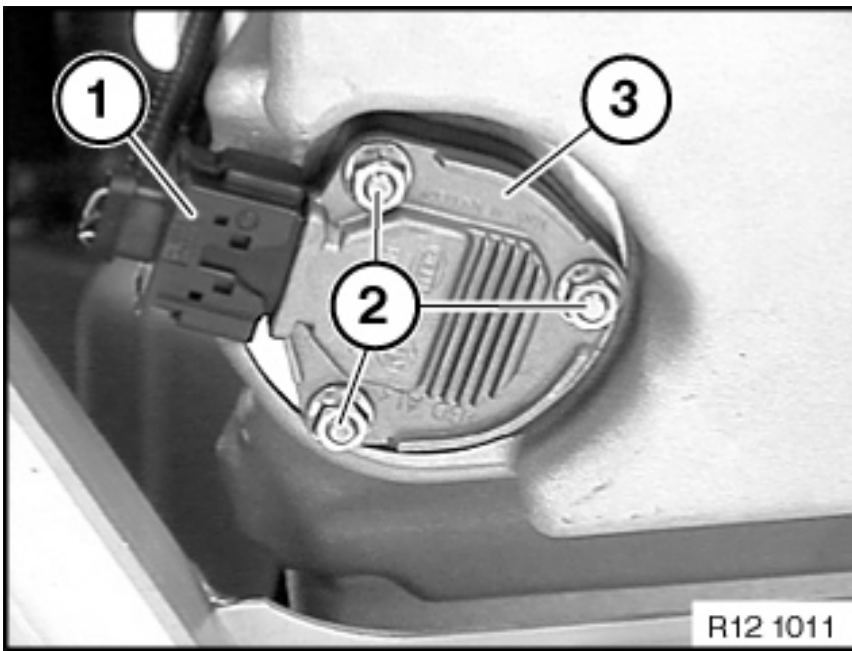
The oil level sensor has been contaminated, reducing the capability of the sensor to accurately determine oil level.

NEW **On a customer complaint basis only**, replace the oil level sensor and refill engine with fresh oil.

Ensure the engine is warm. Loosen oil filter cover to allow engine oil to drain into oil pan. Raise vehicle on hoist. Remove any underbody paneling or reinforcement as necessary to gain access to the sensor. Drain the oil. Disconnect the plug connection (1) and unscrew the three nuts (2) fastening the sensor to the oil pan. Clean the sealing surface of the oil pan in the location of the sensor. Replace the sensor and gasket ring with new parts. Reinstall the underbody paneling or reinforcement and lower vehicle. Tighten the oil filter housing cover and refill crankcase to proper level with new oil. **Do not reuse the original oil!**
